Tomás Caldeira Lourenço
Licenciado em Ciências de Engenharia Civil

Anomalies detection in adhesive wall tiling systems by infrared thermography

Dissertação para obtenção do Grau de Mestre em
Engenharia Civil – Perfil de Construção

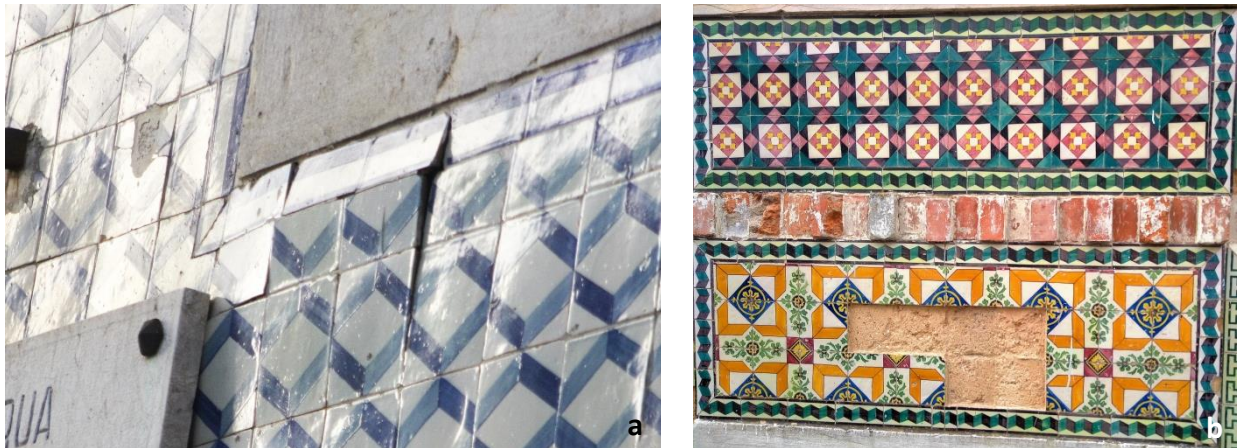
Figure 1 – Examples of detachments in glazed tiling systems in Lisbon: with buckling (a) and with the falling of tiles (b)

- the second is the detachment with buckling (fig. 1a) which “occurs when compressive forces induced into the tile system overcome the bond between the tile and substrate. The compressive forces are typically the result of expansive forces created during moisture or thermal exposure, and the effect from these forces may be exacerbated by restraining forces from inherent shrinkage of concrete substrates or the lack of movement joints” (Bart B. Barrett et al.);

- finally there is the detachment with the total separation of the cladding from the support (fig. 1b), resulting in the release of the tile (by gravity on walls or by “explosive release” in floors (Silvestre et al. 2004)); this is obviously the final phase of the detachment and also the one that most compromises not only the facade but the security.

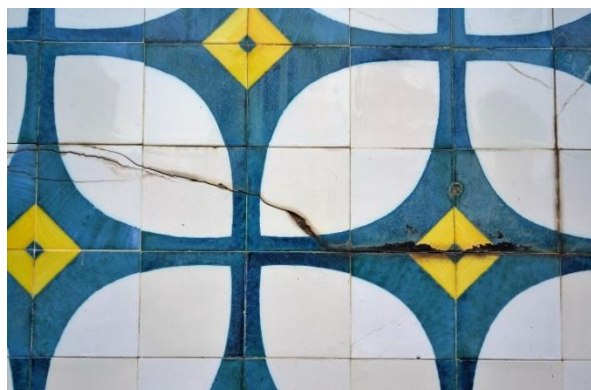
Figure 2 – Example of cracking in one of the case studies that will be presented

It consists in the opening of breaches (fig. 2) in the surface of the cladding that can either be superficial, in the tile glazing or the tile layer, or deeper, up to the adhesive mortar layer. The cracking results from the occurrence of tensile stress in the tiles layer greater than the tensile strength of the tiles. This phenomenon mainly occurs each time the adhesion strength between the tiles and the mortar is high. When that adhesion strength is low, the tensile stress in the tiles layer causes the detachment of this element (Silvestre et al. 2008, 2009a).

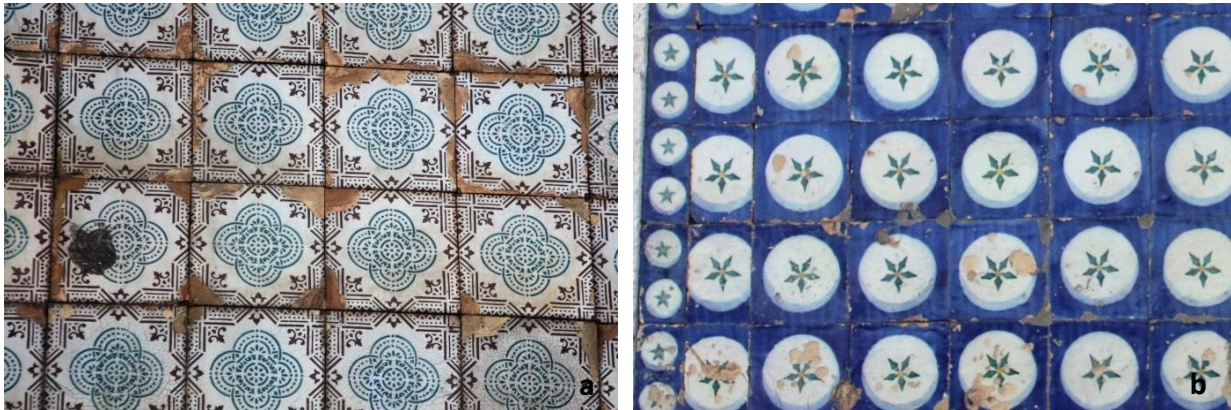
Figure 3 – Two examples of glazed tiles edges' crushing

This anomaly (fig. 3) is mainly due to differential movements of the support/cladding that result in the tiles compression and consequently the edges' crushing (Carvalho Lucas; 2001).

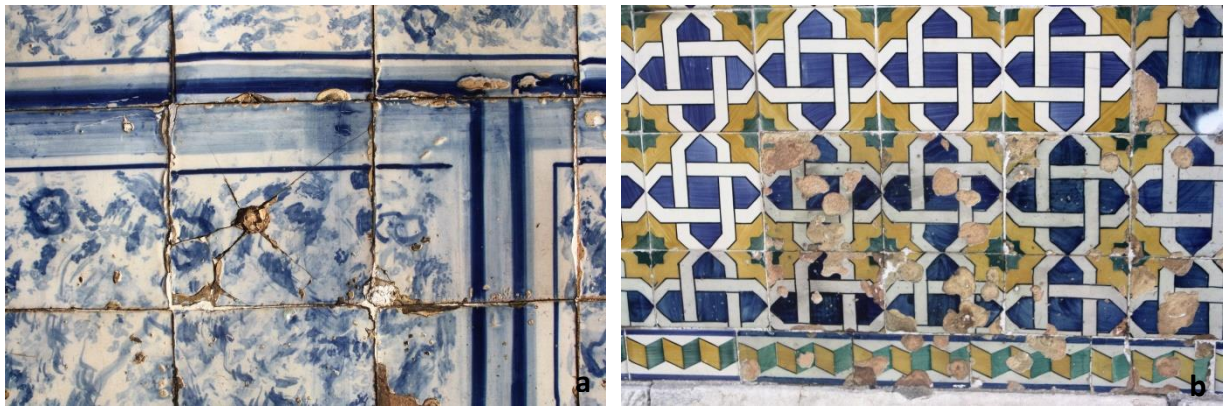
Figure 5 - Two examples of glaze detachment/cracking

Glaze detachment/cracking consists in the appearing of craters or superficial cracks in the tile's surface, often leading to its partial or global loss, owing to a lack of resistance from the tile's outer layer against actions such as freeze-thaw, impact or excessive tile's deformation (fig. 5). This anomaly not only has aesthetic impact but it can also compromise the cladding's efficiency, once the most water resistant layer of the tile can be lost.

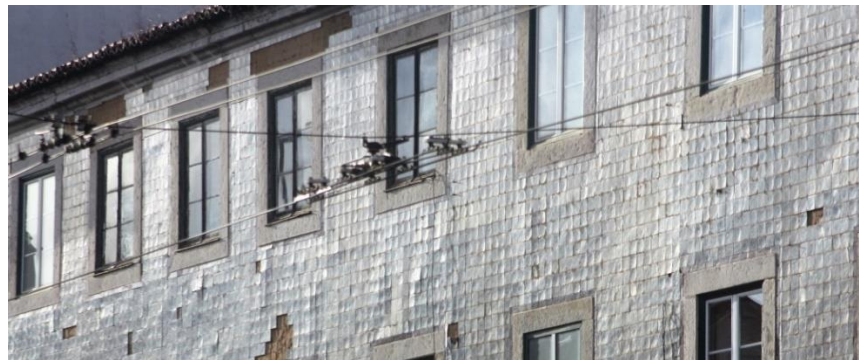
Figure 6 – Example of a building with flatness deficiencies, probably a sign of detachment

The irregularities in the cladding flatness are usually caused by the incorrect application of the tiles or a faulty preparation of the support. It can also be a sign of the cladding's buckling/detachment (fig. 6).

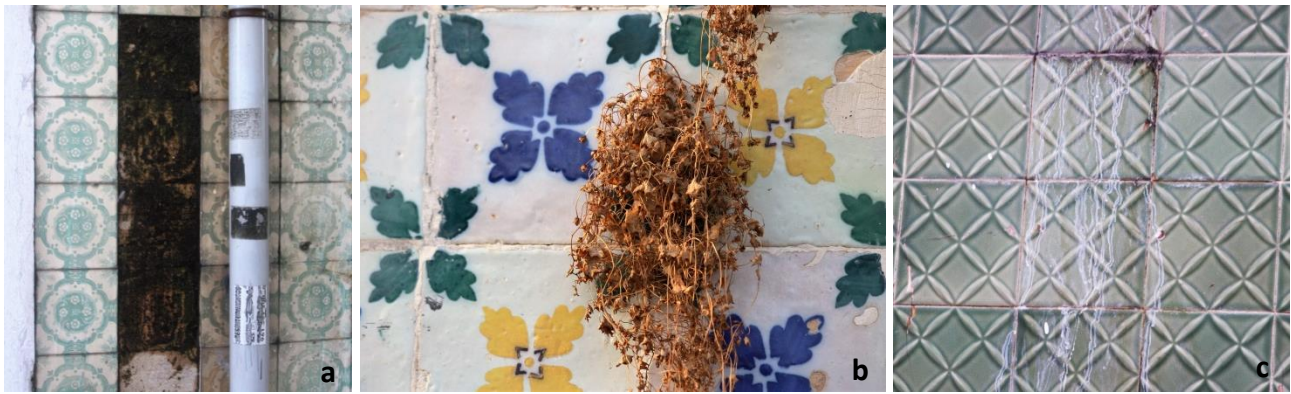
Figure 7 – Three examples of moisture related anomalies (bio-contamination (a), vegetation growth (b) and efflorescences (a))

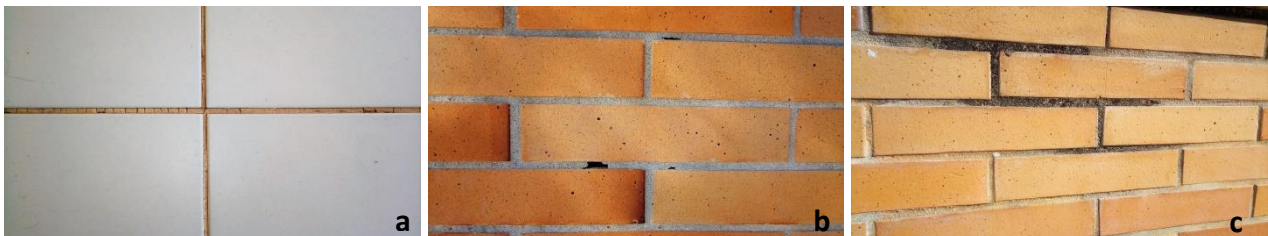
Figure 8 – Examples of Joint's cracking (a), detachment of the grout (b) and biodeterioration (c)

- efflorescences;
- colour change;
- cracking (fig. 8a);
- detachment of the grout (fig. 8b);
- biodeterioration (fig. 8c);
- dust trapping.

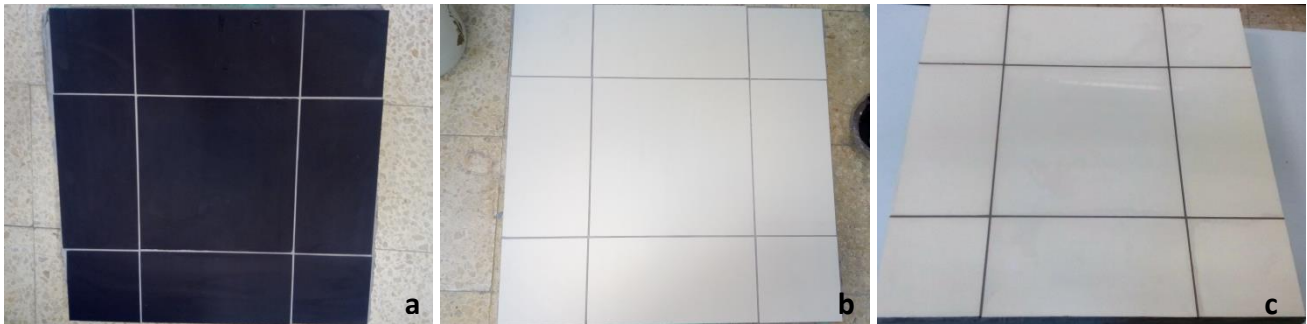
Figure 31 – Specimens *Bti* (a), *Wl* (b) and *Wpol* (c)

After the specimen's drying, the 2mm joints between tiles were filled with *Weber.color premium* [TS3] (cement mortar with organic and inorganic admixtures and mineral pigments, waterproof and reinforced with fibres), a mortar designed for a flat joint finishing, between 2 and 15 mm, both for indoor and outdoor conditions. The joint filling process was the same for all the specimens. In figure 31 it is possible to see the aspect of three finished specimens (the rest of the black and white non-polished specimens are similar in aspect to the ones from figures 31a and 31b).

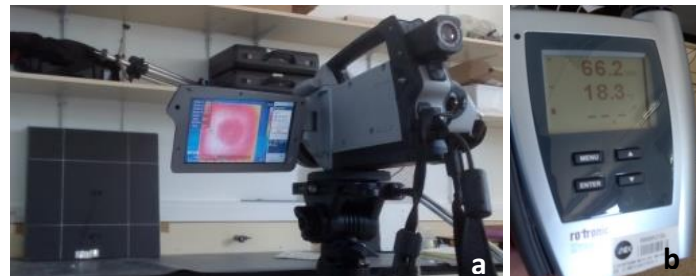
Figure 40 - Thermographic analysis of the specimen's cooldown (a) and ambient temperature and relative humidity monitoring with *Rotronic hygrolog*

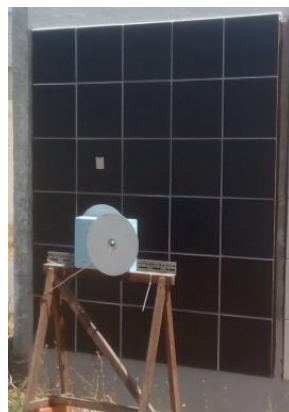
Figure 47 - Reflectance measuring on panel C1_B

Despite the standard procedure consisting in using only one pyranometer, which must be pointed firstly upwards (measuring solar radiation) and then downwards (measuring reflected radiation), the procedure adopted uses two pyranometers mounted in parallel and back to back. Therefore, the incoming and reflected radiation can be measured simultaneously. The instruments used were two *Kipp & Zonen CM5 Pyranometers* (Appendix A.2.), mounted as shown in figure 47.

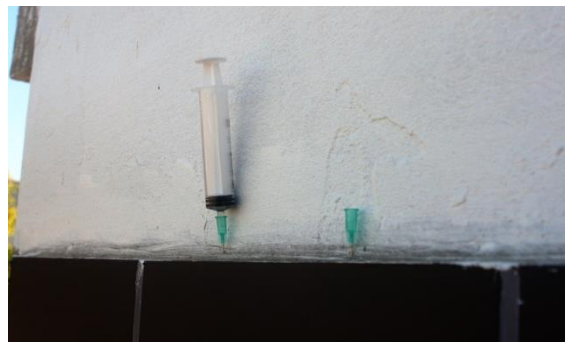
Figure 48 - Injection of water beneath a tile

In order to test humidity detectability water was introduced using a 10 ml syringe beneath each of the two top detached tiles of each panel (fig. 48): on the left, tiles that were applied with a spongy cloth (CT); on the right, tiles with a void (DT). The elasticity of the waterproof polyurethane sealant (*Weber.flex PU*) used to seal the panel's edges allowed the use of syringes to introduce water without damaging the system.
